Efflorescence, Lime Staining and Good Site Practice

Brick Education notes provided by Simon Hay, Chartered Architect, Building Expertise Ltd.

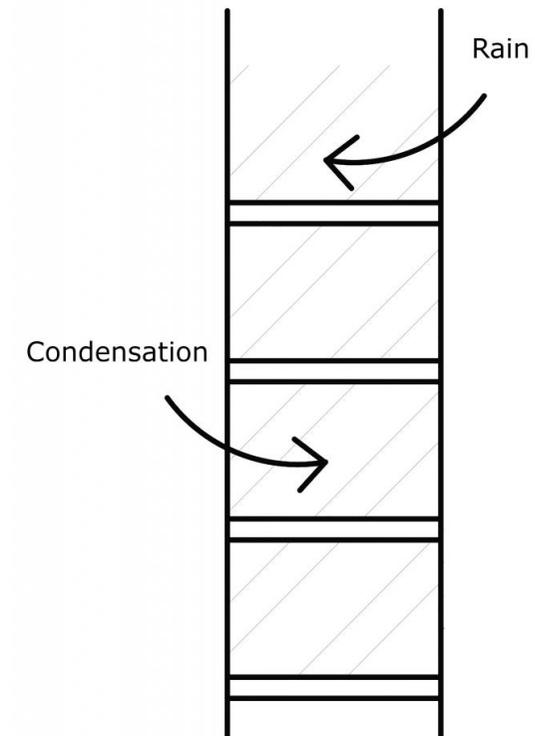
- Mortar must be kept clear from the inside cavity which could otherwise deflect water into the brickwork. Internal snots and mortar which has not been cleaned is unacceptable and may lead to efflorescence. Mortar droppings on wall ties can also cause water to run on the rear of the brick skin.

- Weep holes need to be clear of debris which will collect during and after completion. Cavity trays need to be clear of droppings. If droppings have accumulated, bricks may have to be removed locally to gain access to the cavity.

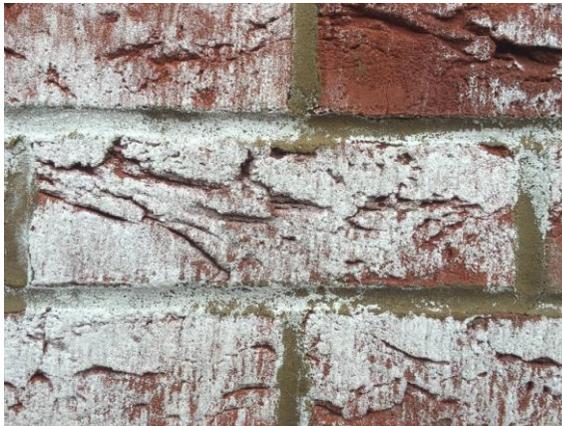
Efflorescence

- Fired clay may contain soluble salts.
- Brickwork when saturated dissolves salts.
- When the brick dries the moisture moves to the surface.
- The moisture evaporates leaving the salts as efflorescence.

The solutions are different; efflorescence should be allowed to weather away naturally and no spraying is advised. The salts may be brushed away with a bristle brush and taken away from the wall. High pressure washing will make the issue worse as when the bricks dry, more salts are drawn out and redeposited.

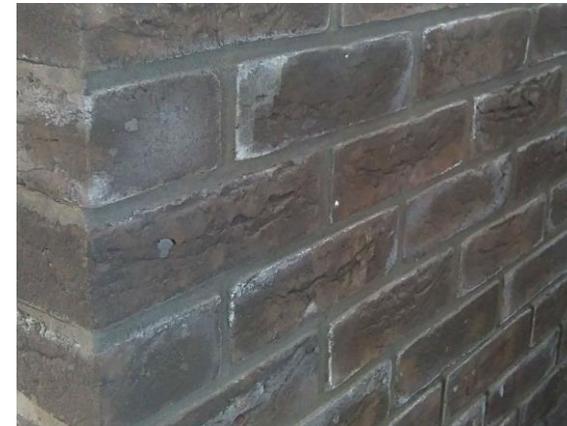
Lime Staining

Lime staining is the deposit of calcium carbonate by reacting to the atmosphere on to the face of the brickwork. Lime staining can be distinguished by the flat top to the staining stemming from the bedjoint, or alternatively fanning out from the cross joint, clearly associated with the horizontal or vertical joints.

- The wall is unprotected and becomes saturated.
- Free lime released by the mortar seeps out of the joints.
- Calcium hydroxide is formed on the surface turning into Calcium Carbonate or Limestone which is impervious to water.

Lime is normally removed by proprietary acid brick cleaner. Unlike efflorescence speed is vital and if the calcium carbonate is allowed to solidify back into limestone only specialists will be able to remove it.
