Firecracking – Fissures in Clay Brickwork

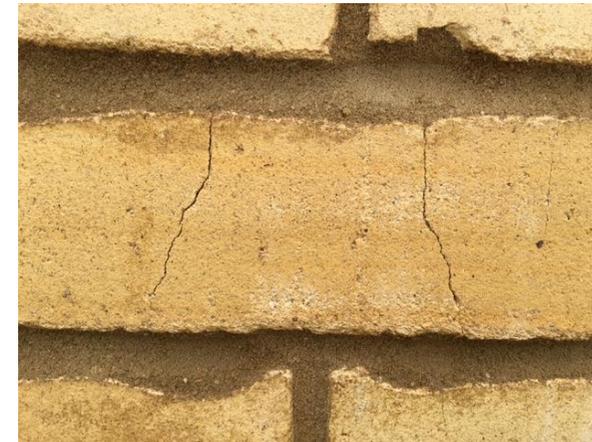
fired to a high temperature and consequently will be both durable, and weather satisfactorily. It is true that it would be undesirable that a fissure would extend more than 30mm into a brick but with a standard brick of 102.5mm, this still allows 70mm of clay body to protect the cavity and so this is not a concern.

If the distance is greater than 20mm the brick should be cut out and replaced, or alternatively, filled in situ with a colour matching epoxy and finished with a colour matching sand. Well done, this should be invisible especially when viewed from the correct distance of 3M or 10ft as required by Publicly Available Specification 70. As cut and bond bricks account for over 2 out of 3 specials currently in production, there should be no concern over the use of this technology.

If the fissure is narrow, (less than 2mm) then the forces generated by freeze, thaw and expanding moisture lodged in the cracks is insignificant. It will not cause the cracks to grow worse when built into a cavity wall and protected by mortar above and below, especially as one side of a crack will be open, permitting expansion. If the crack is greater than 3mm this could generate greater
